## Executed project report

### Slope consolidation in the Palangrers Beach (Roses, Girona)

**Stakeholder of the project:** Naturalea

**Client:** Rosersa

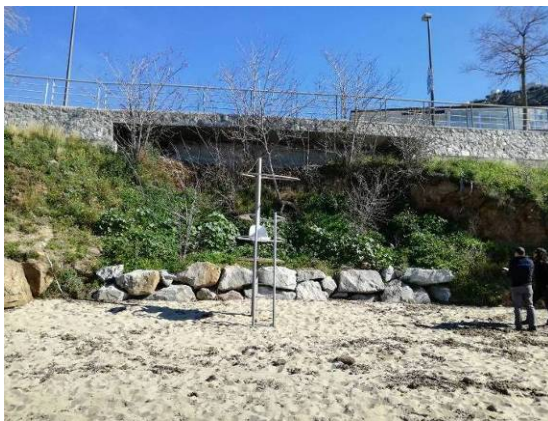
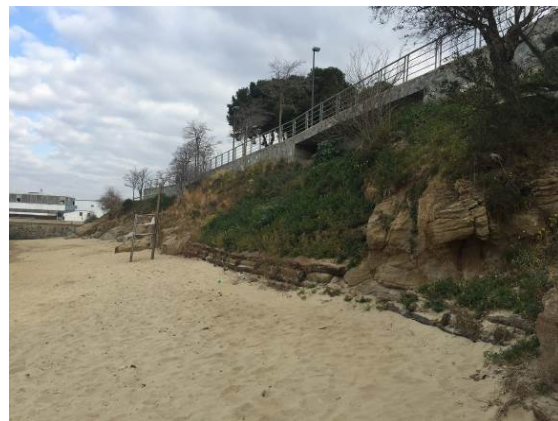
BEFORE

AFTER

The present intervention has solved the slopes problem while gaining landscape quality. To achieve this, landscape bioengineering techniques have been used in a remarkable intervention because it has been done in front of the sea. It is one of the first projects at European and probably global level where techniques such as the crib wall have been used in an area so close to the sea using typical species of these areas and local helophytes.

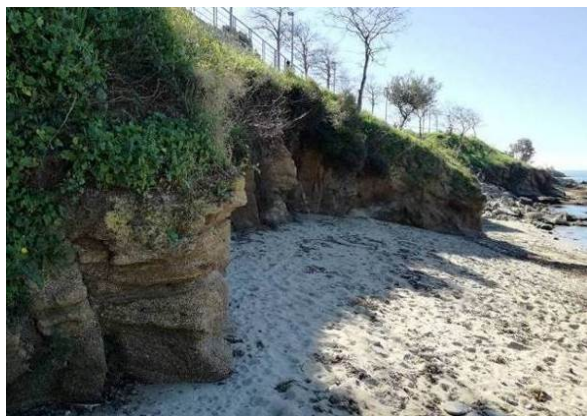
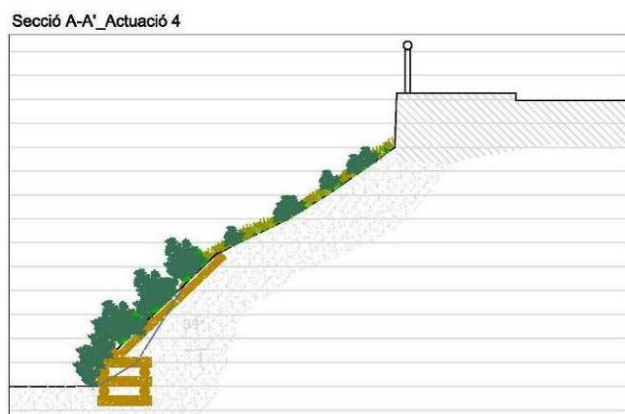
It is an area treated directly from the beach with active erosion. As the lower part of the slope was lowered, it collapsed, and progressively more important slopes were generated.

It is an area of **9 meters long** with a practically vertical slope of 2 meters high and a slope about 45 degrees 4 meters long and below.

In order to create the right conditions for the development of the plant, a base of a crib wall and a slope grid in the upper area has been implemented.

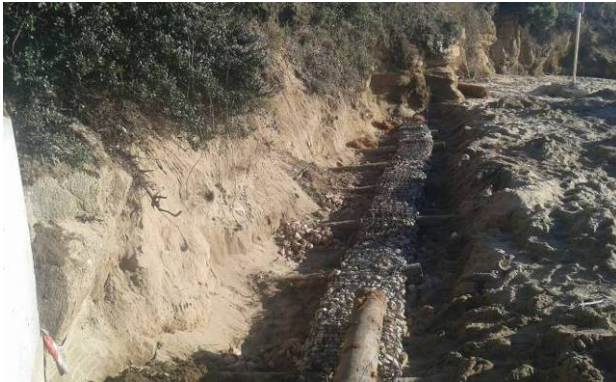
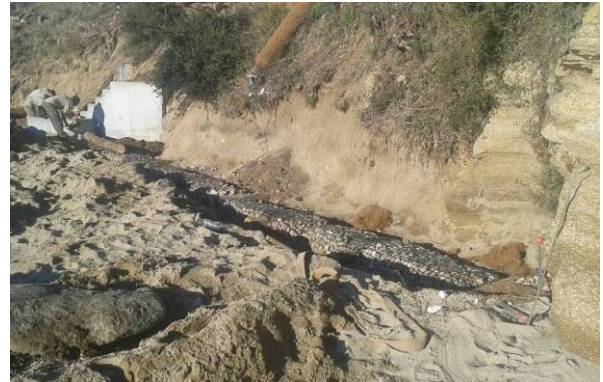
Detail of the foundations:

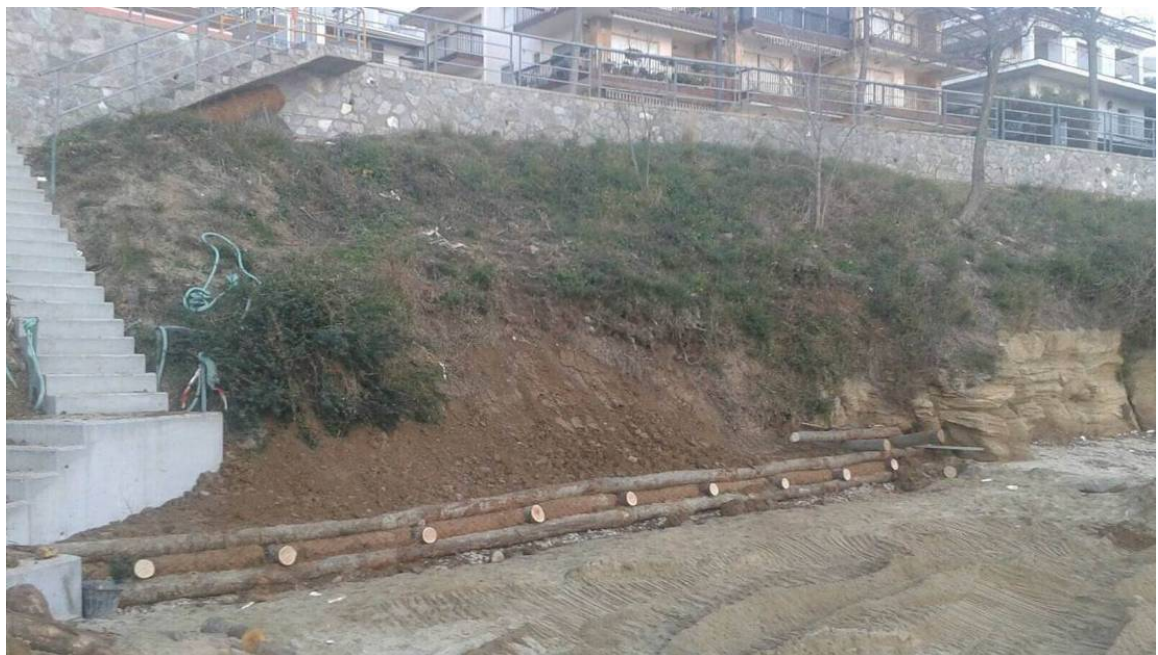
Naturalea cribwall:

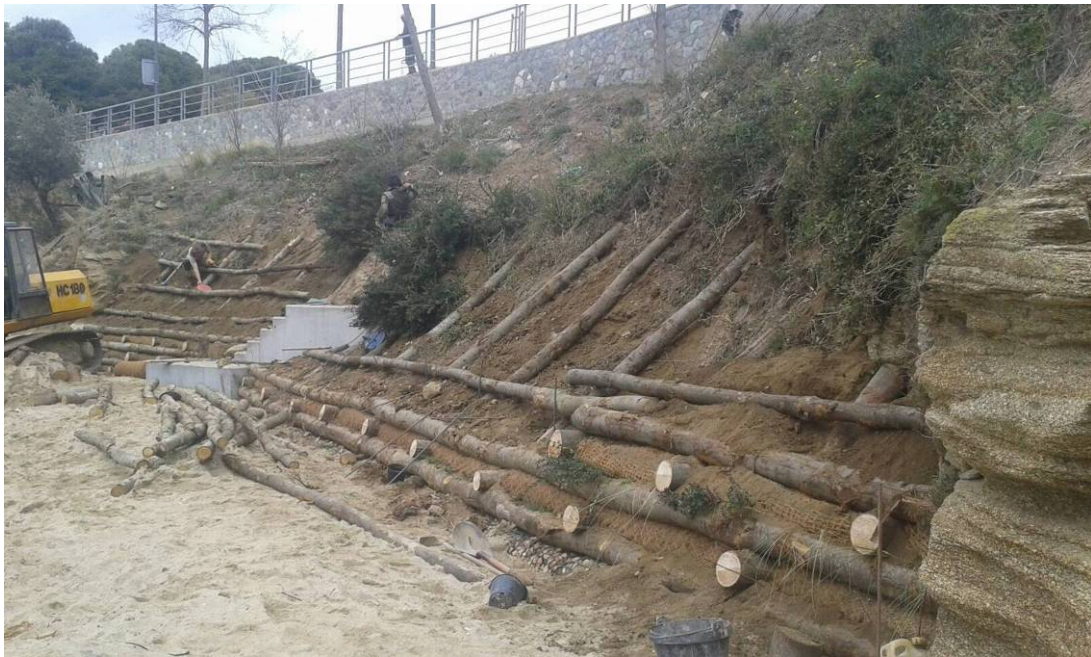
Slope grid during the construction:

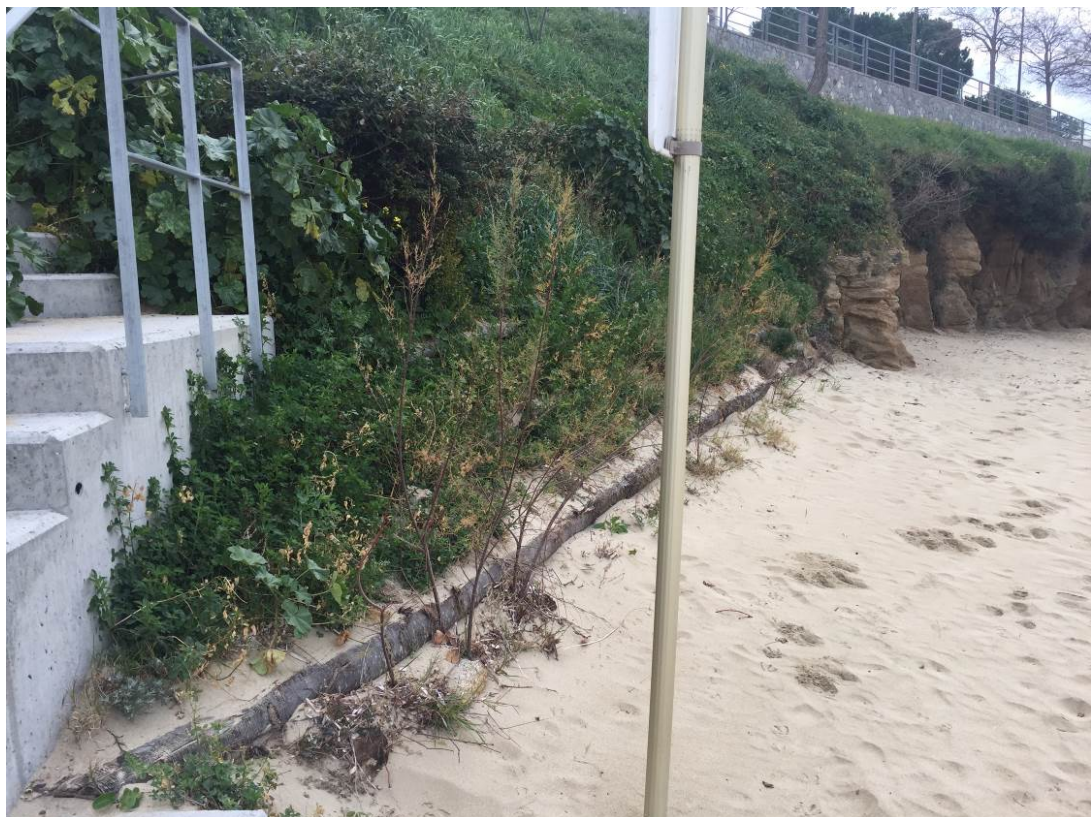
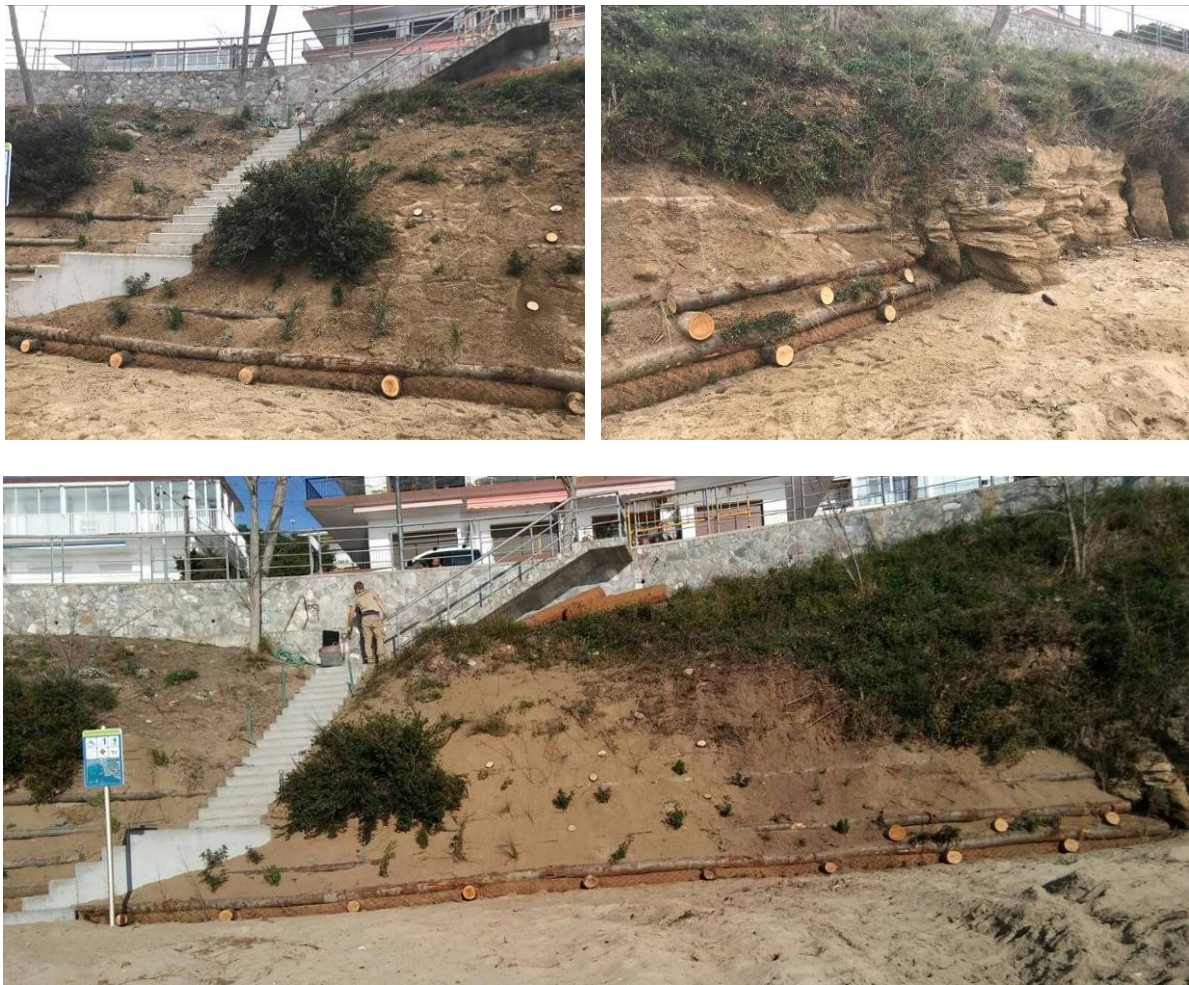
Images of the finished action:

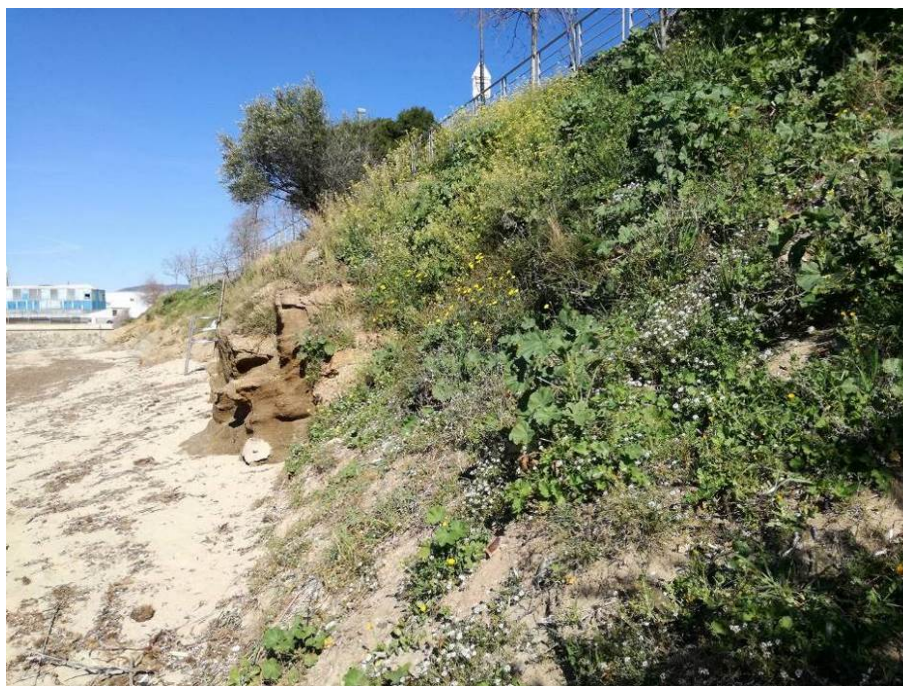
A section of **11 meters** corresponding to a slope of sand has had the base stabilized to prevent the zone from being eroded, and later more suitable species have been introduced in this area. Up to the upper part, there is a slope of an average height of **8 meters**, which means a total area of **88 m<sup>2</sup>**.

A treatment similar to the Action 1 was done to a slope that suffered a landslide by the construction of stairs.

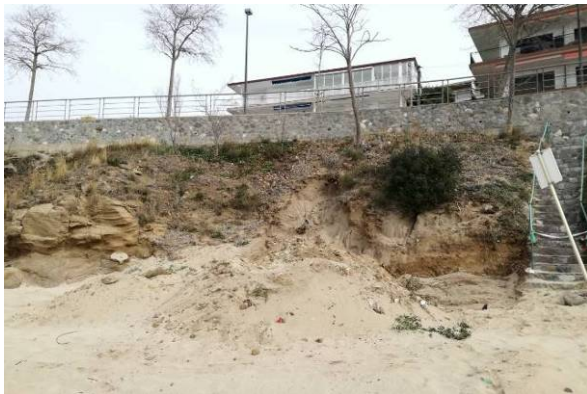
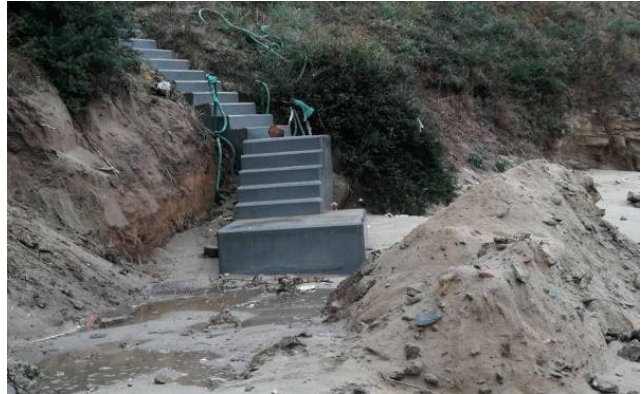
Initial situation of the zone:

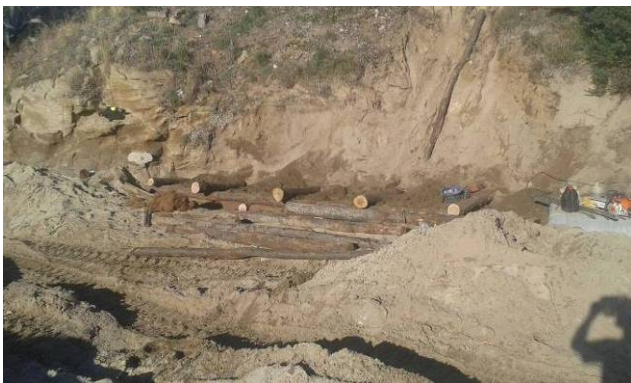
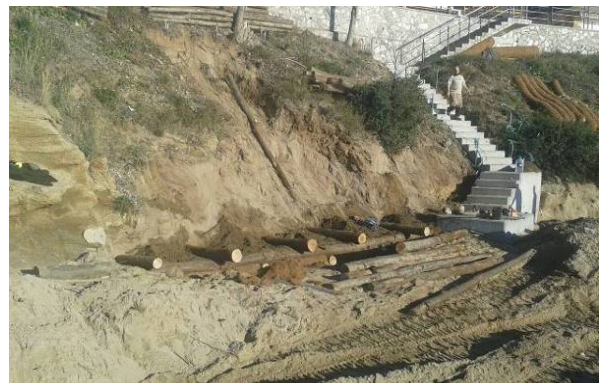
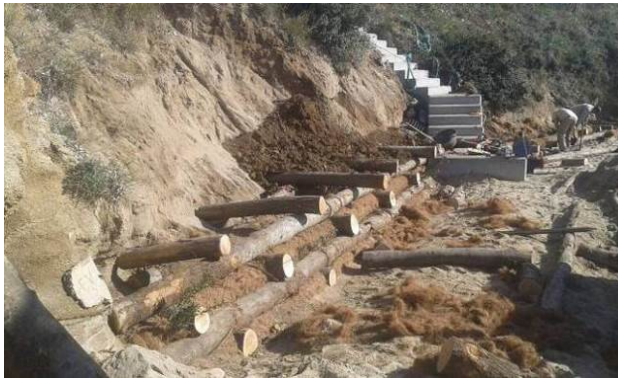
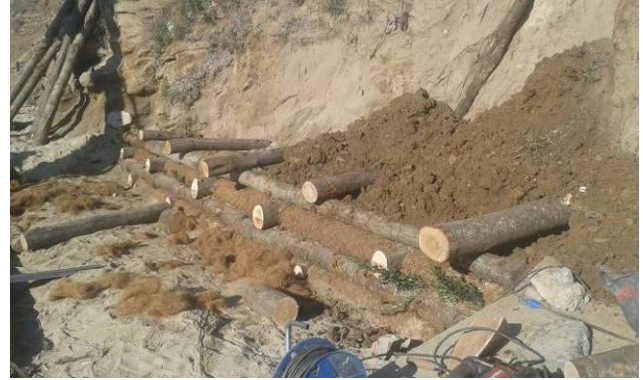
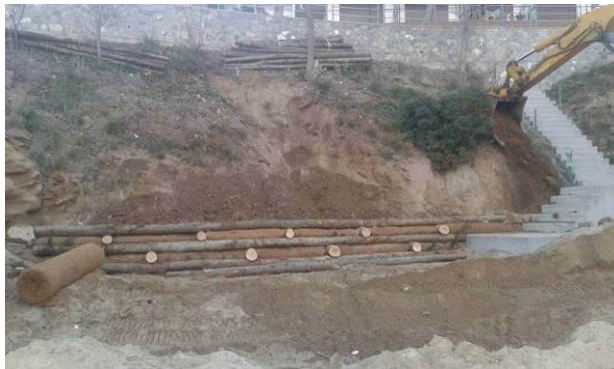
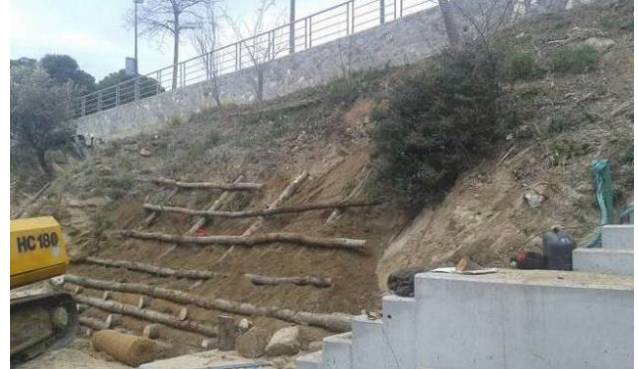
Construction process:

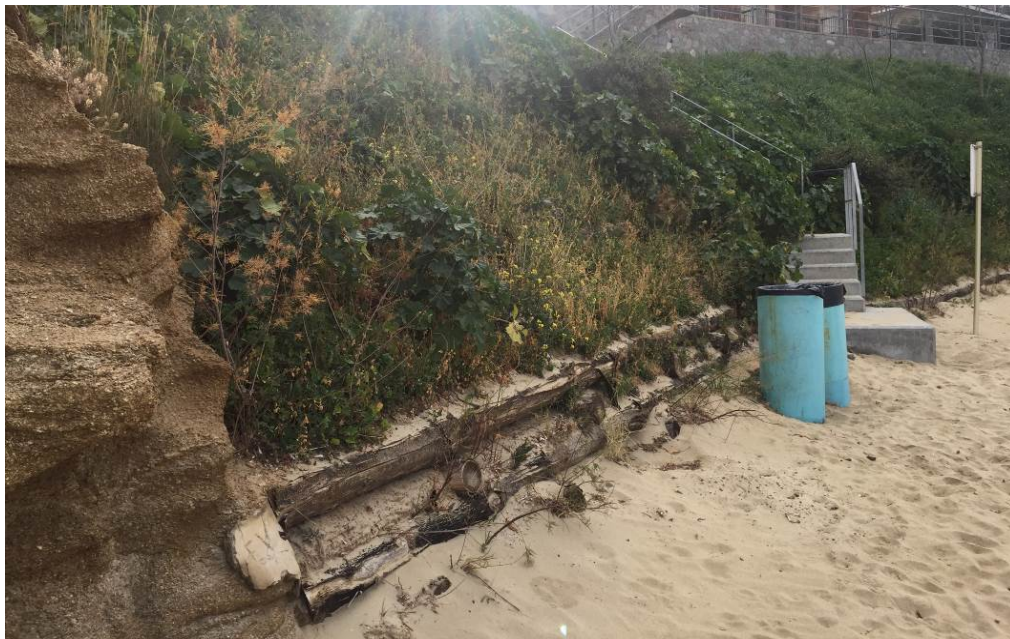
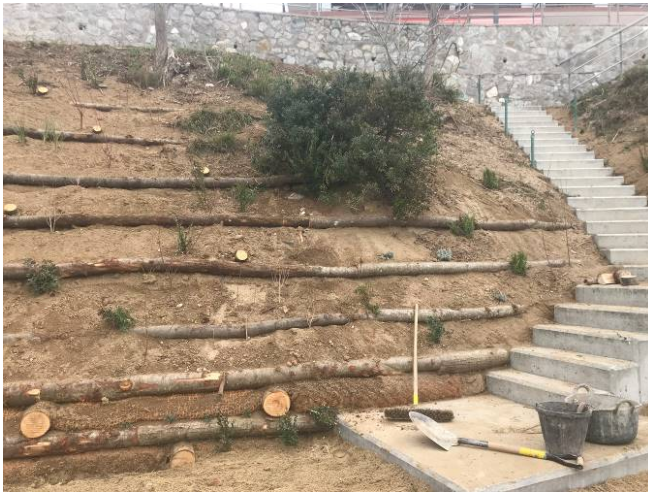
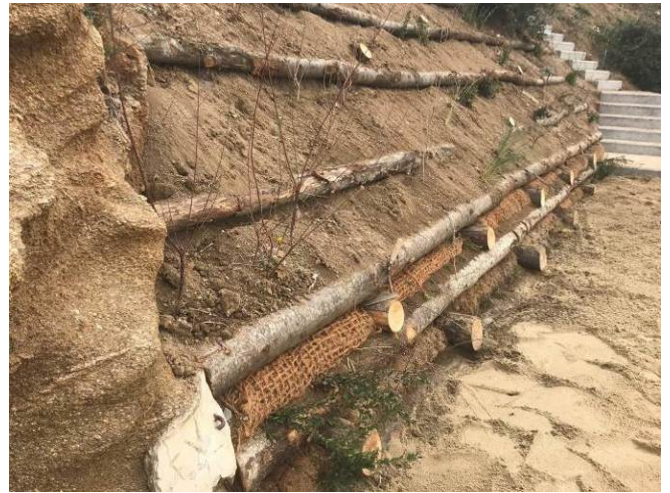
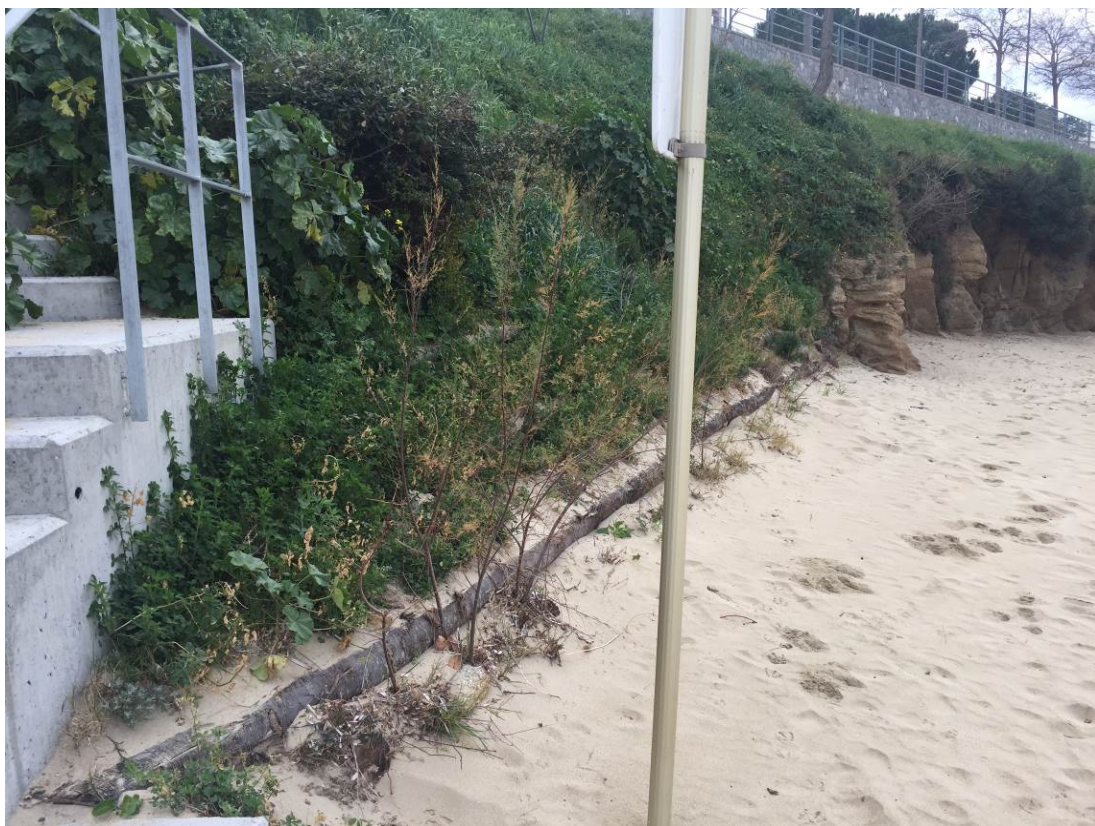
Final result:

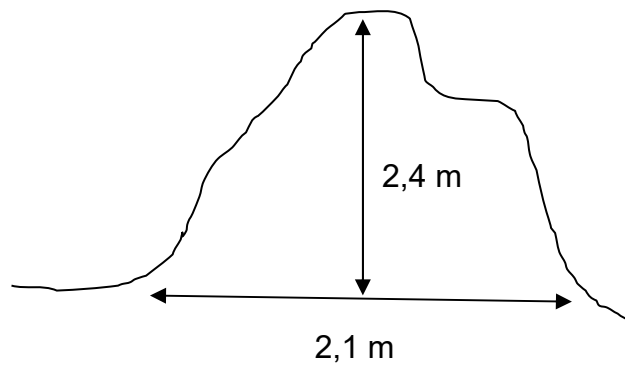
This intervention is located in a small stretch, where erosion was active between two rocky areas. The stretch has a width of 2,1 meters, and goes 2,4 meters inside the slope. Stabilizing the first 1,2 meters the erosion can be stopped.

Viewed from above:

A simple crib wall of 1,2 m was built in a wall that occupies all the space between the two rocks (2,1 meters). It allows the fulfilment between the structure and the rocks, protecting the base (the weakest part of the slope).

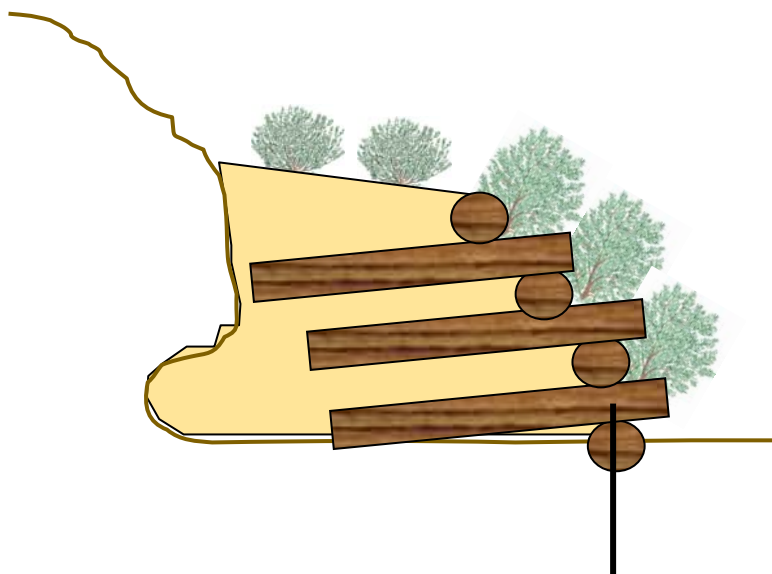
Scheme of the intervention:

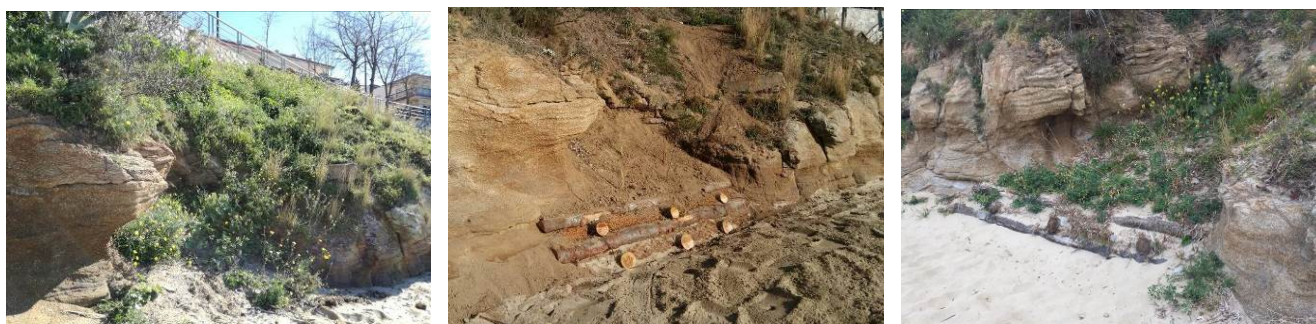
Final result:

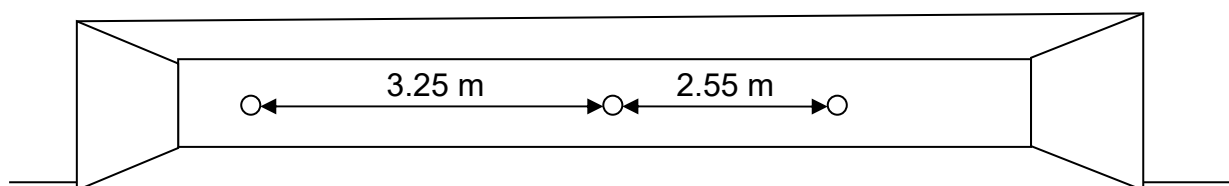
It is one of the two areas with more erosion problems, contained by the presence of a breakwater on the front. The length of the current breakwater was 9.3 meters but in fact, relocating the platform, a structure has been placed 1,2 meters ahead, so that the structure has 15,4 meters following the majority profile of the zone.

This structure consolidates the entire section of the base of the street wall, so the projection behind the intervention has an impact on an area of 11,3 meters. These 11,3 meters correspond to a section where the street makes a small cantilever and at the bottom of the wall three drainage pipes are located. This fact is incorporated in the design of the solution, which in addition can mean an interesting water contribution of the waters that emerge from the drainage tubes.

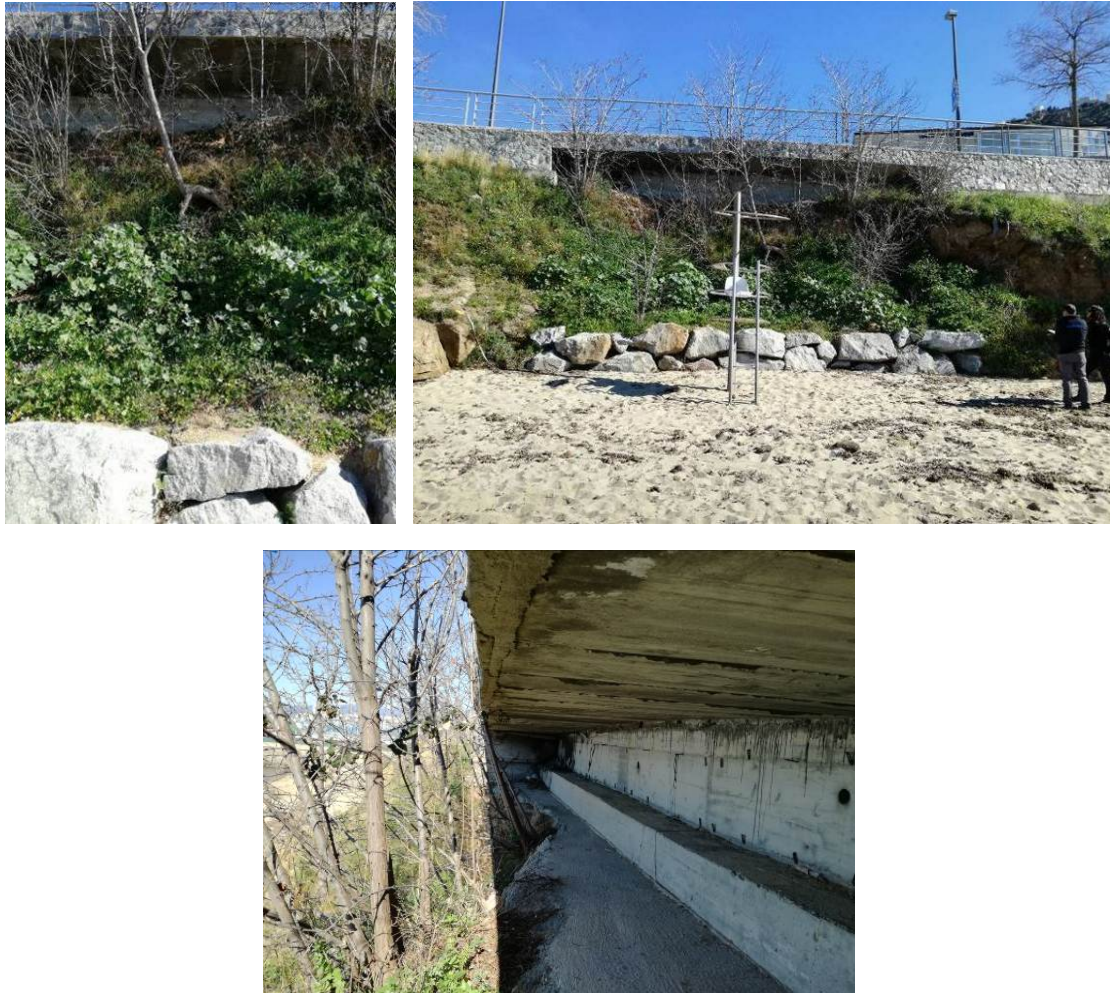
Images of the zone:

The solution consists in two lines of double crib wall or Naturalea-type Krainer. Between crib walls and in the top part the new profile was stabilized with seeding mat (in slopes with a 50 degrees slope). The slope is more pronounced in one of the margins, where palisades were made to improve the consolidation of the contributed soil.

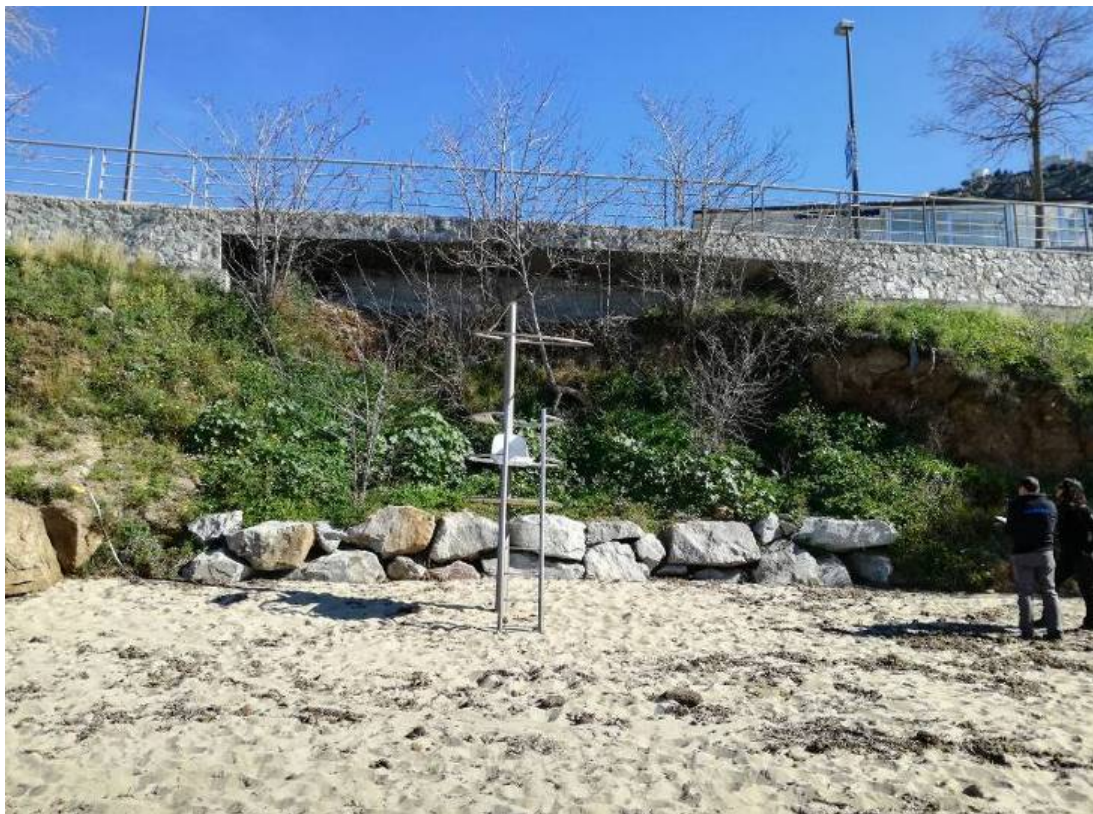
Image before the intervention:

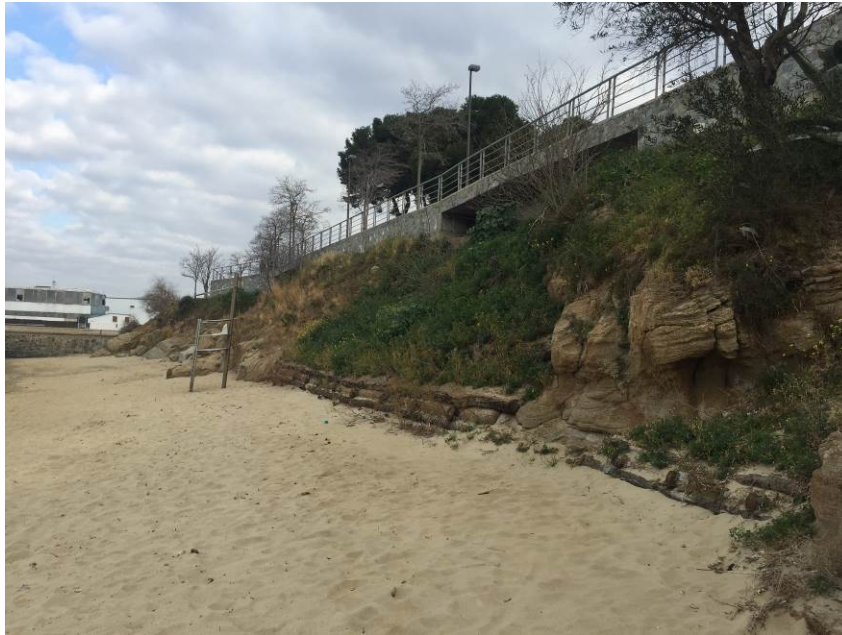
Image after the intervention:

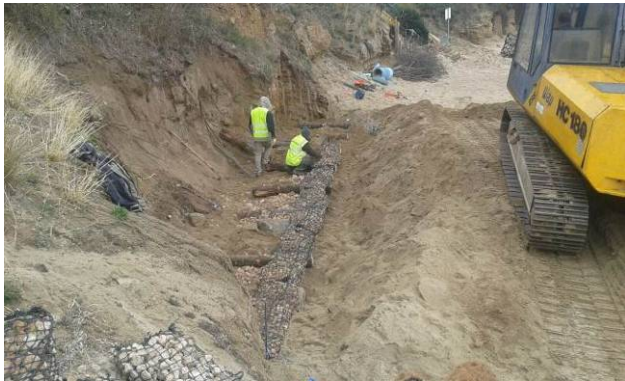
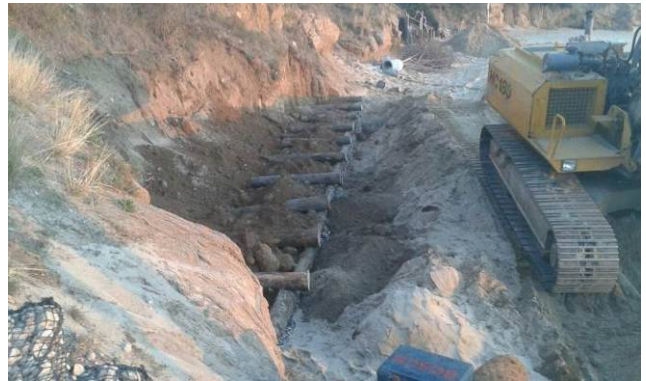
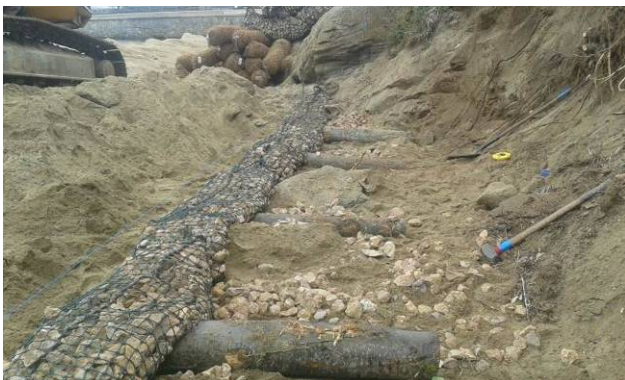
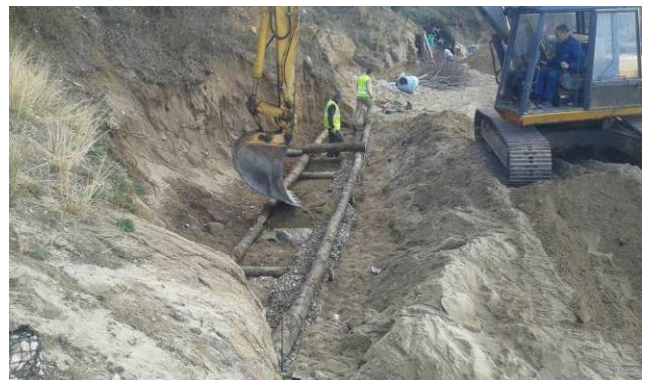
Preparation of the foundations:

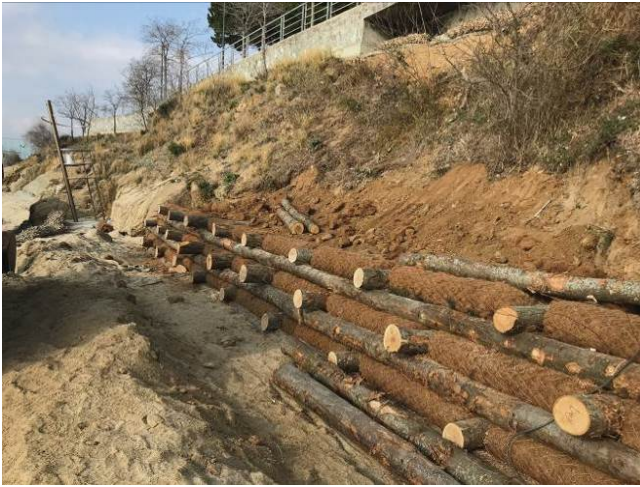
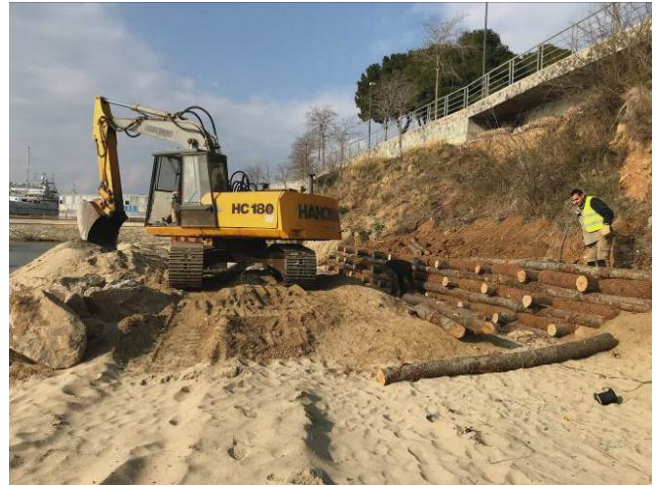
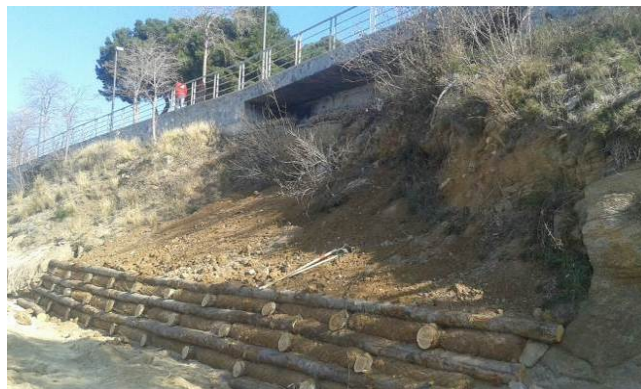
### Lower crib wall:

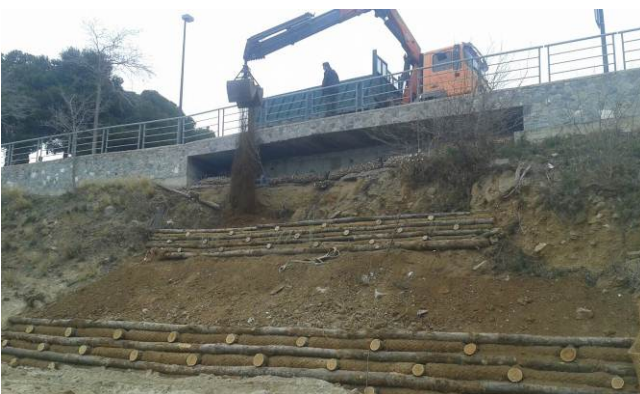
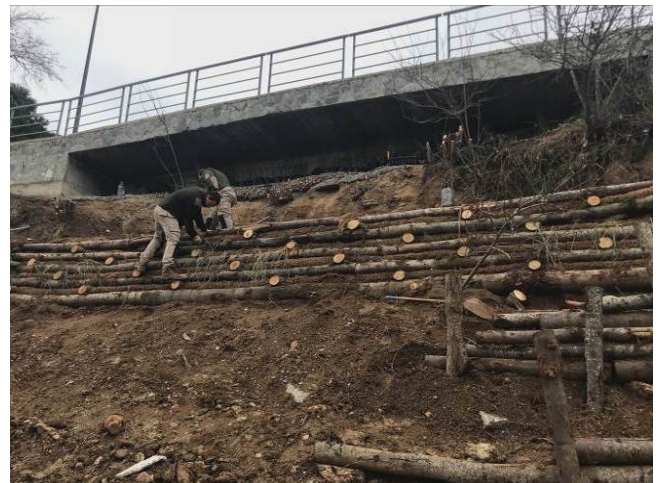
### Upper crib wall:

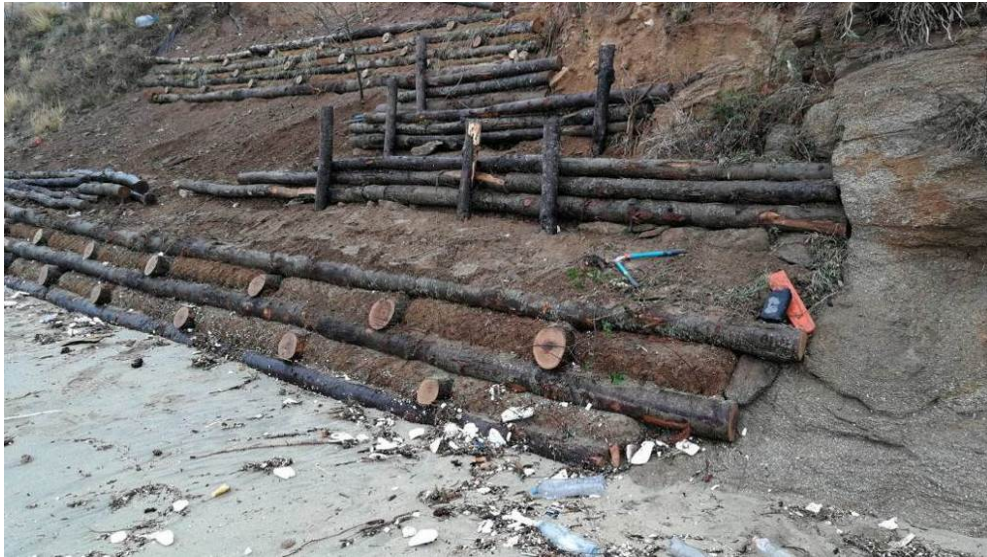
Palisade in construction:

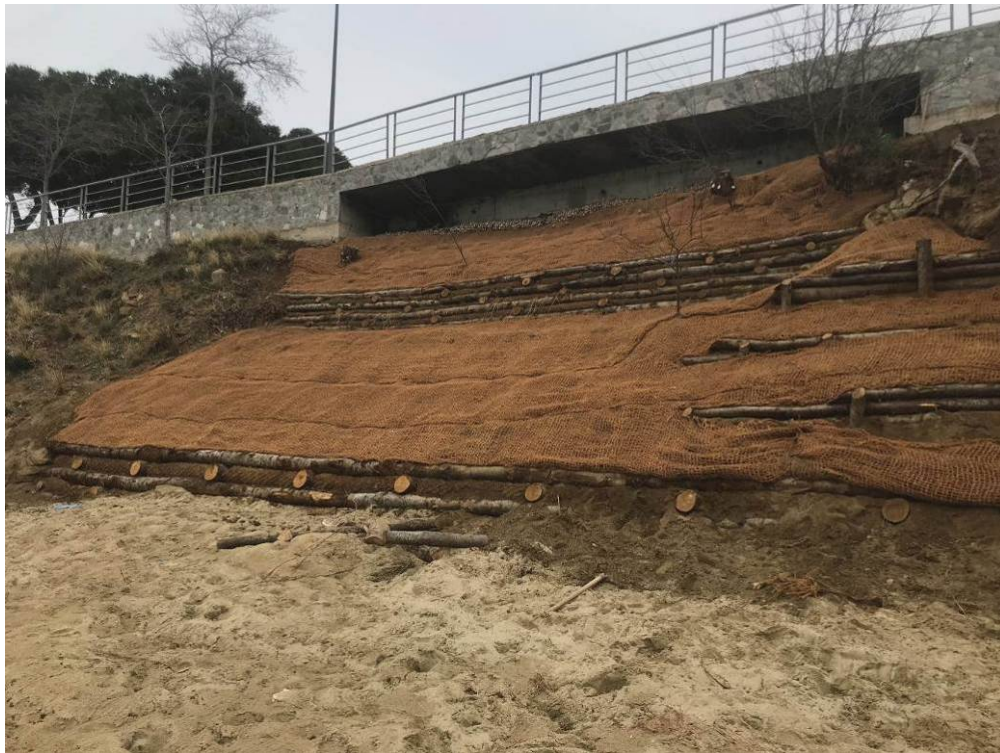
Installed seeding mat:

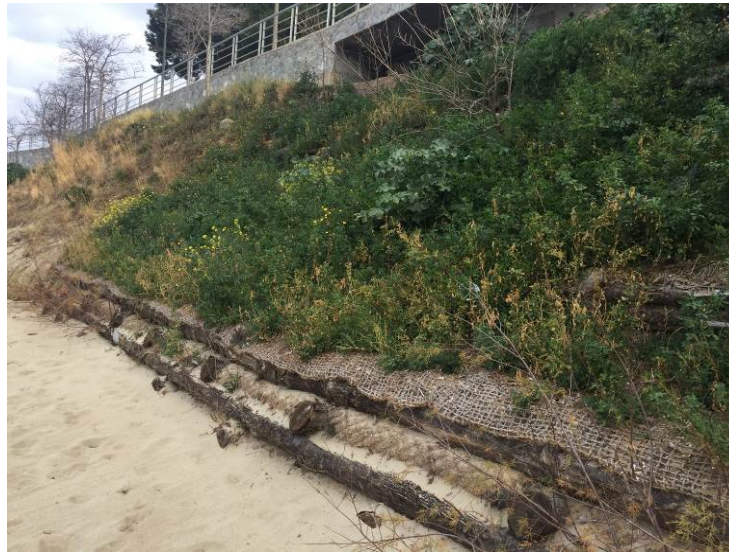
Vegetated construction:

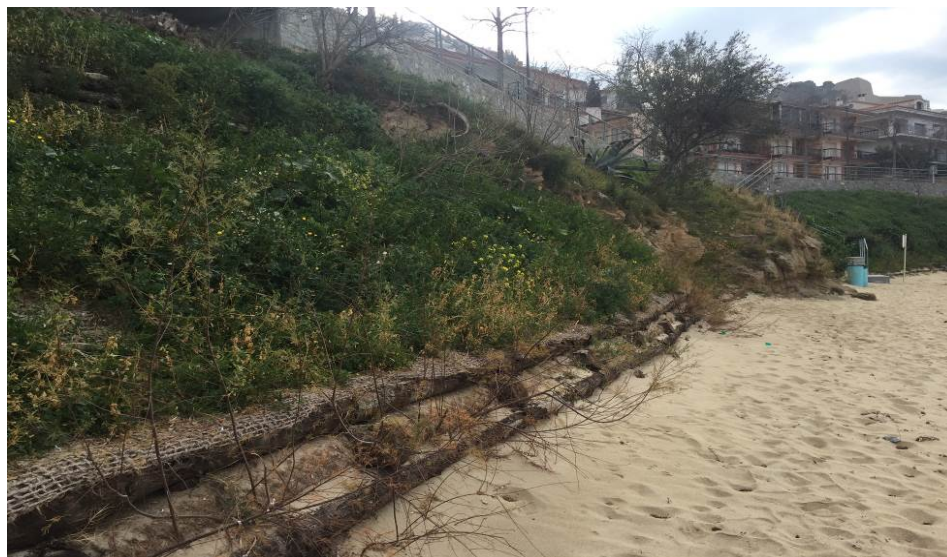
General view of the interventions:
