## Executed project report

### Creation of a wildlife pond in a drainage stormwater channel at Winery Torres, Vilafranca del Penedès, Barcelona

**Author of the proposal:** Naturalea

**Client:** Winery Torres

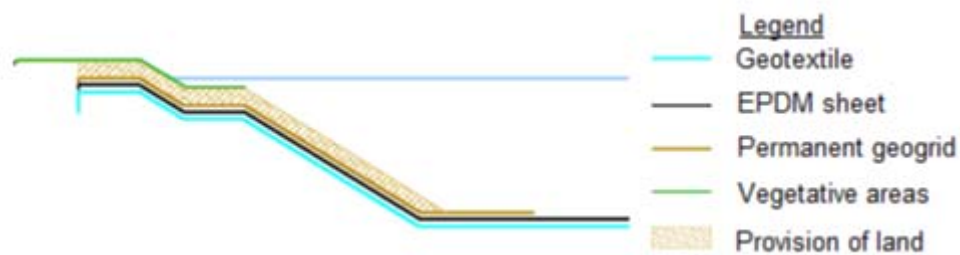
For waterproofing, a geotextile sheet, an EPDM type waterproof sheet and a C350 Vmax type permanent geogrid have been installed on the excavated surface. The permanent geogrid creates friction so gives soil cohesion, the root system of the plants also improves it. This is also an impermeable protection against big mammals like wild pigs that can damage the system.

The diagram below shows how it is waterproofed:

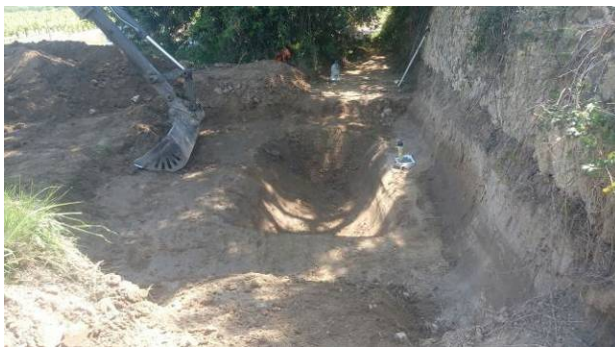
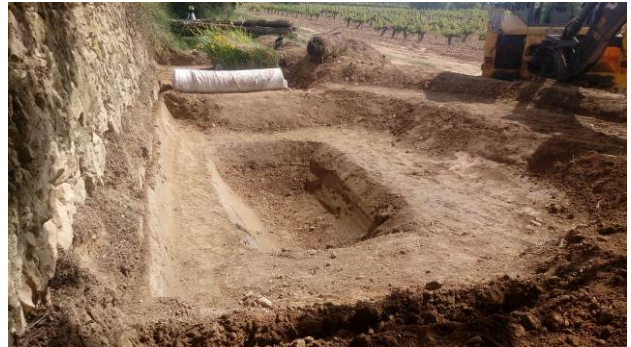
Excavation works.

To create a pond with a maximum depth at the central point of 1m, controlled excavation work has been carried out with a topography level to generate the appropriate terraces and place pre-vegetated material with helophytes. These creates an immediate ecosystem to improve biodiversity and reduces the risk of insect's plague.

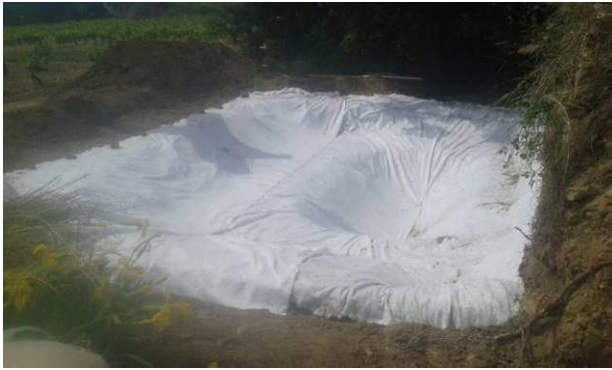
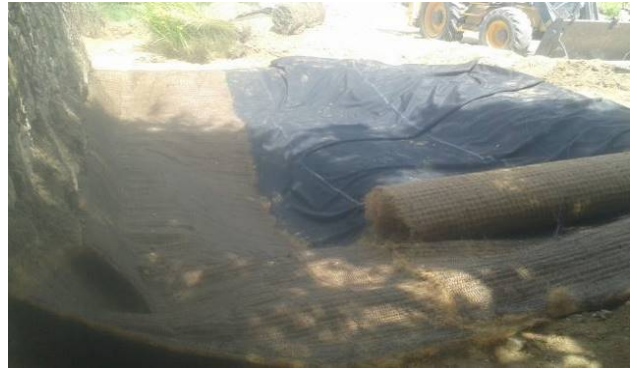
Geotextile installed after excavation.

EPDM sheet installed on the geotextile and permanent geogrid type C350 Vmax in the process of installation.

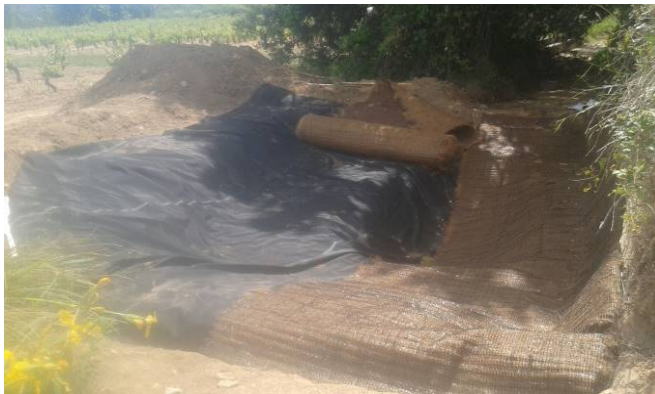
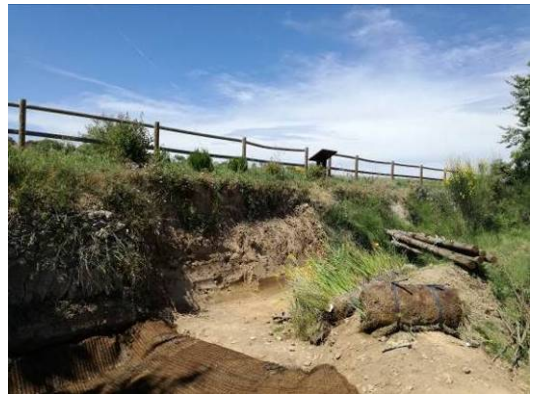
Installation of permanent geogrid / Pre-vegetated plant material stocked in the area.

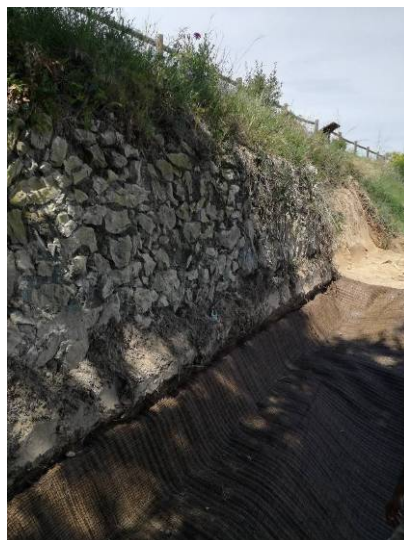
Detail of the fitting of the C350 Vmax permanent geogrid and the existing stone wall.

Once the three materials are in place, a layer of soil of approximately 30-45 cm has been placed on top of the geogrid.

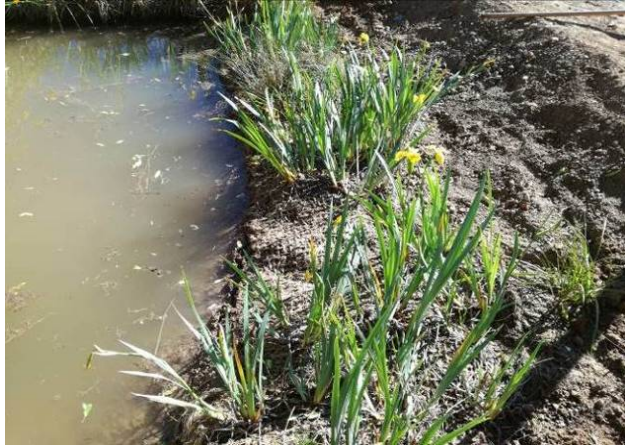
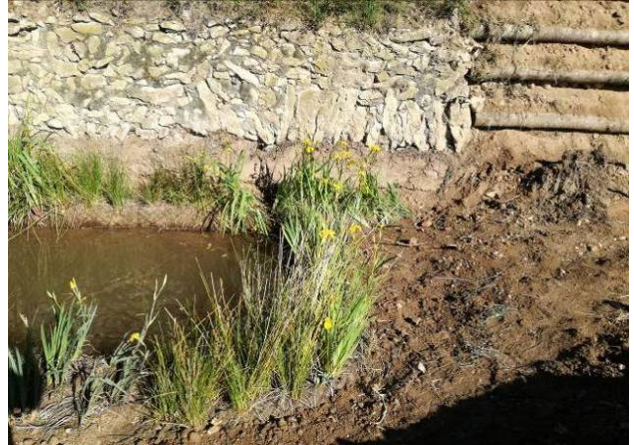
Plurispecific grasslands type Plant Carpet installed on one side of the pond (left).  
Vegetated roll type Fiber Roll installed at the base of the stone wall and at the entrance to the pond (right).

- 9 m of vegetated rolls type Fiber Roll, in the margin under the stone wall and in the point where the water is received from the channel.
- 5 m<sup>2</sup> of plurispecific grasslands type Plant Carpet.
- Stone from the stacked area generating holes between the mud at the point where the water comes out.
- 5 m of live willow fascine at the point of entry of the water into the pond, buried and above the line of the vegetated roll.

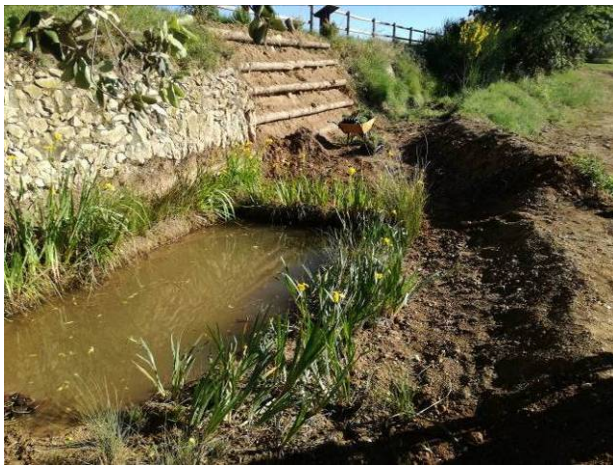
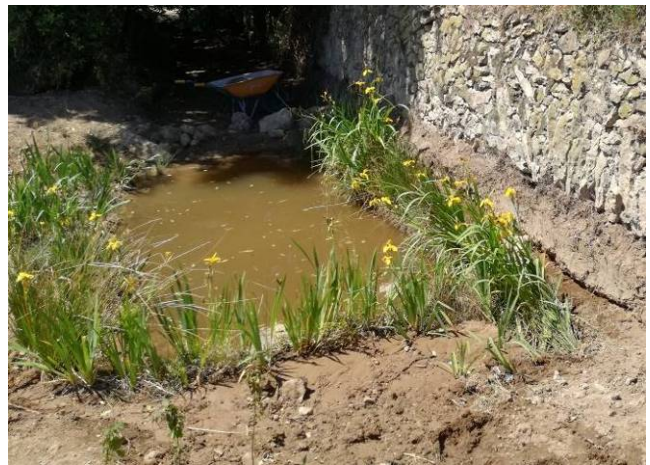
General view of the pond.

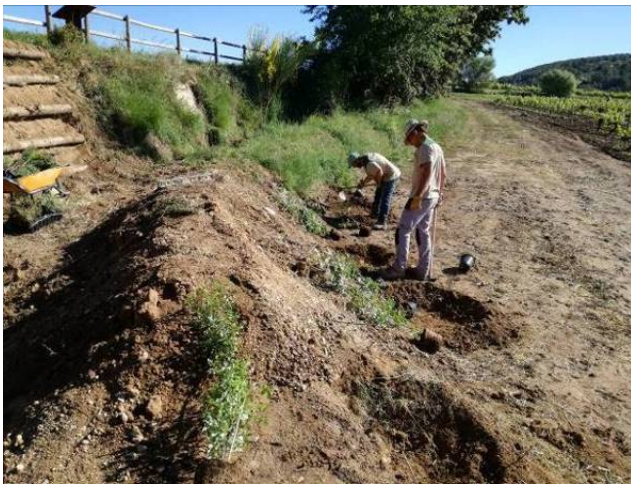
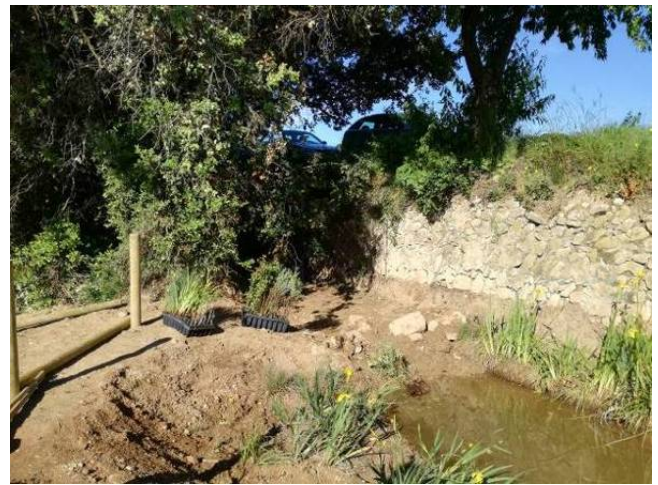
Tree planting work at the margin of the displaced fleck to make space for the pond, and planting helophytes and shrubs on the slopes surrounding the pond.

- 35 helophytes on the outer margin of the pond, near a speck of land.
- 35 bushes on the speck of land in groups of 5-7 specimens of the same species to favour their growth.
- 6 ash trees and 2 oaks of 1m of height planted throughout the area in the external margin of the channel.

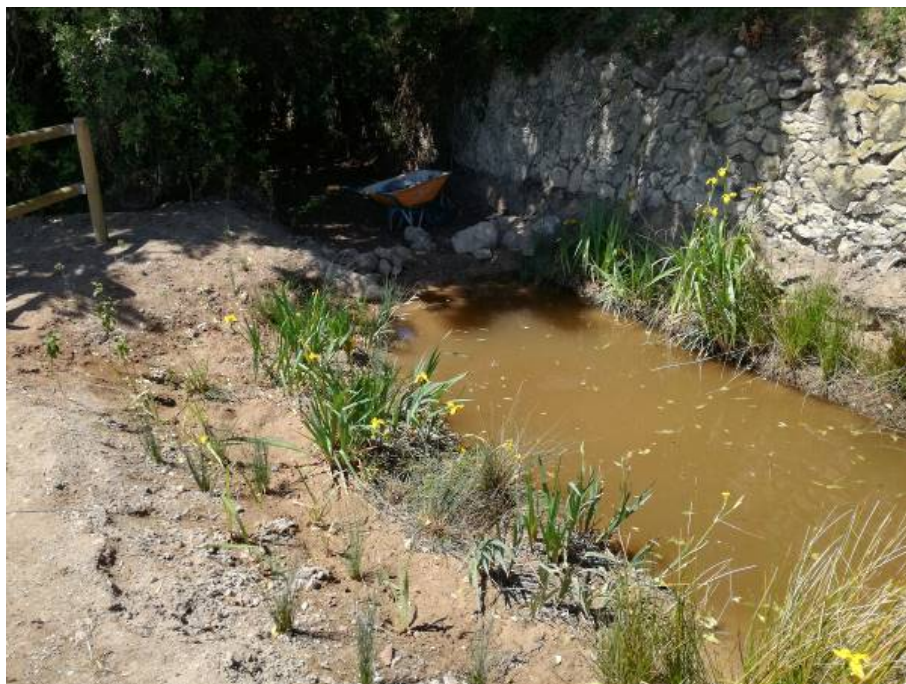
Planting of helophytes and bushes behind the herbaceous area.

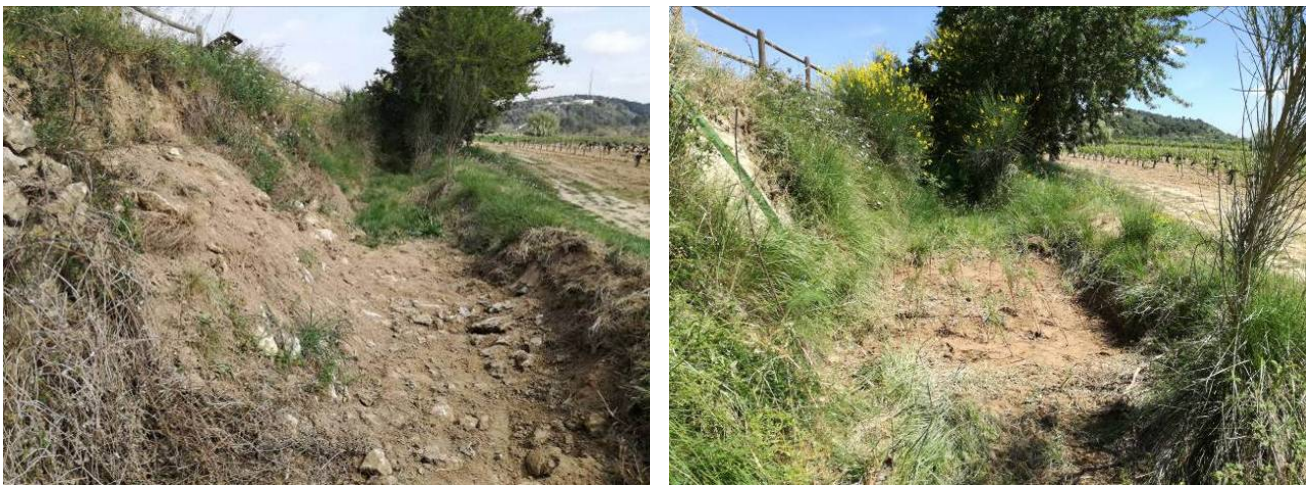
Image of the area where the sediment trap has been located, before and after the actions.

A large part of the water that will reach the new pond will do so through a drainage channel between fields. To prevent the pond from becoming clogged by the input of fines from the channel, a structure has been made which, once vegetated, will reduce the speed of the water causing sedimentation and therefore reducing the arrival of sediments in the pond.

On a 2m width along the drainage channel, upstream of the pond created, two transverse live fascines have been installed, completely buried, like a continuous linear natural live filters when the plants grow. In addition, 20 specimens of *Salix eleagnos* have been planted between the two fascines to increase the density.

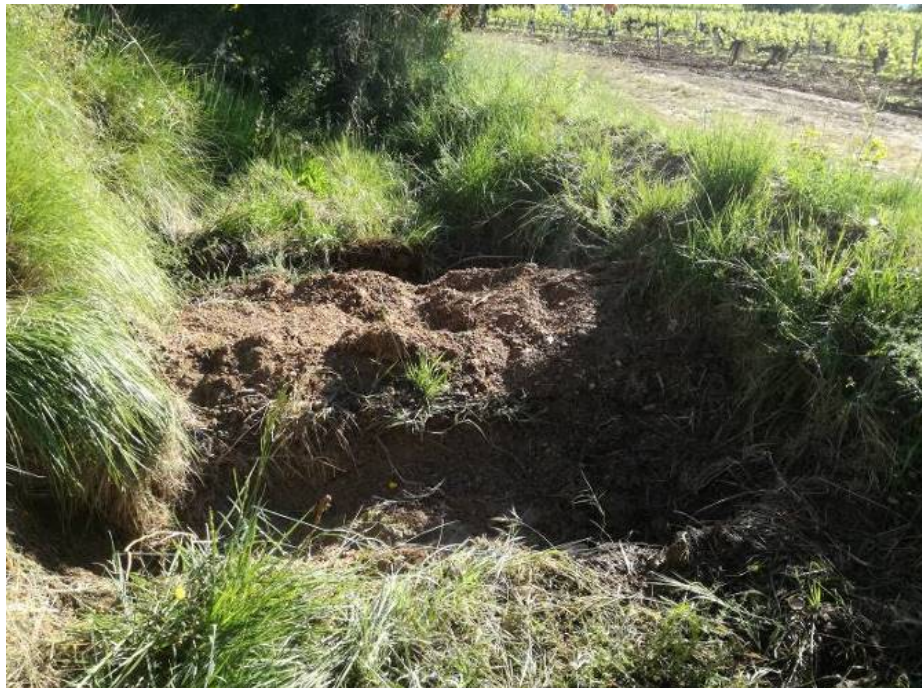
Excavation of the two trenches where the live willow fascines have been placed.

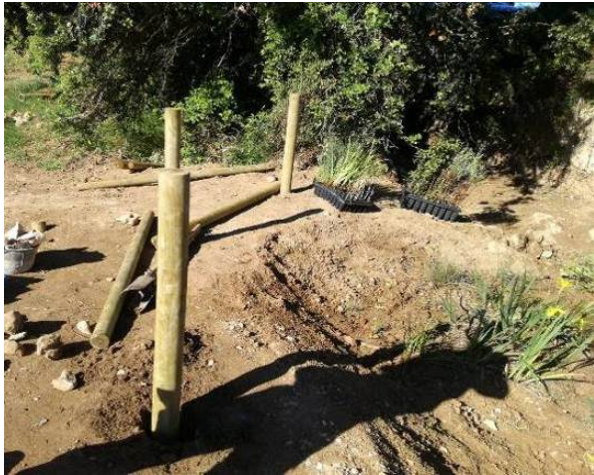
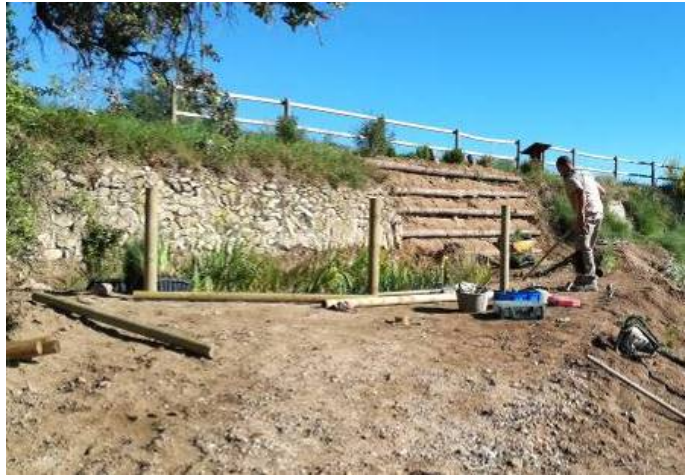
Installation work of the wooden fence at the margin of the pond.

A 6m section of treated wood fence has been installed at the connection point between the pond and the platform.

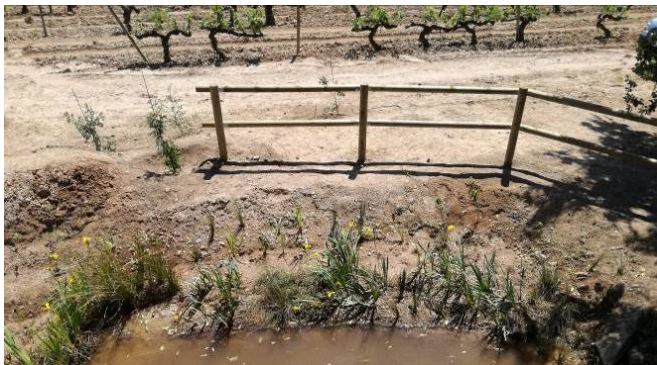
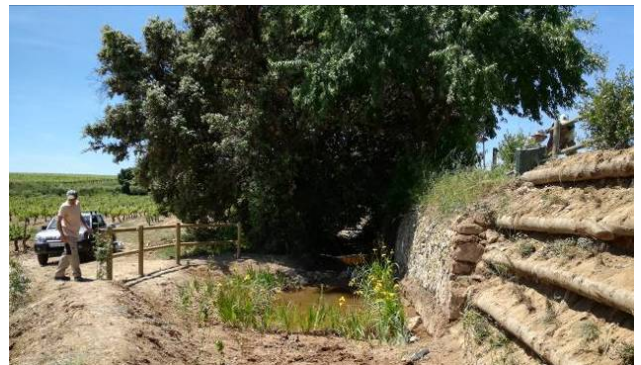
Wooden fence on the margin of the installed raft.

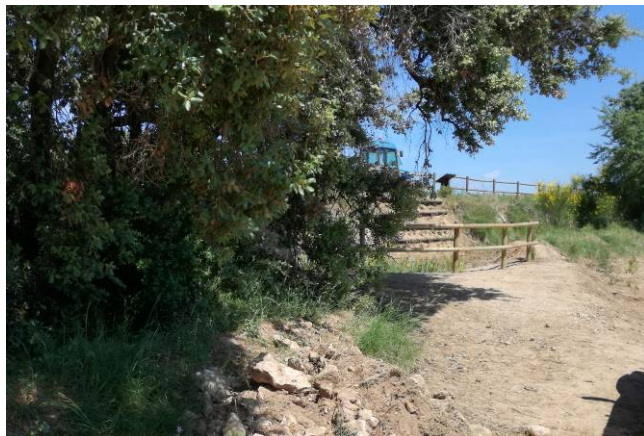
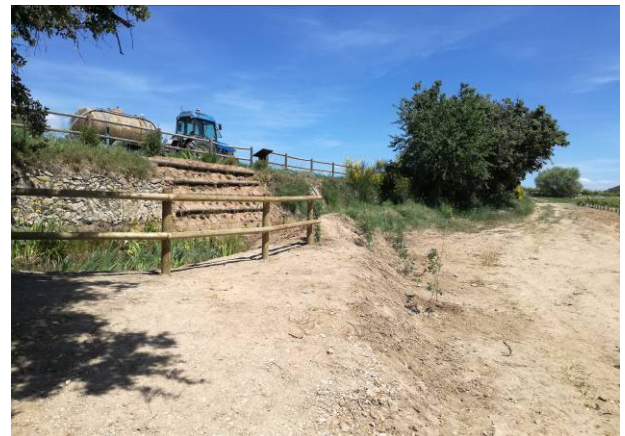
Front view of the access ramp / Transition between the access ramp and the ground fleck that defines the channel.

In order to allow the observation of the pond, an access ramp has been created using the remaining soil from the excavation. In this way the pond can be observed from a high and comfortable point.

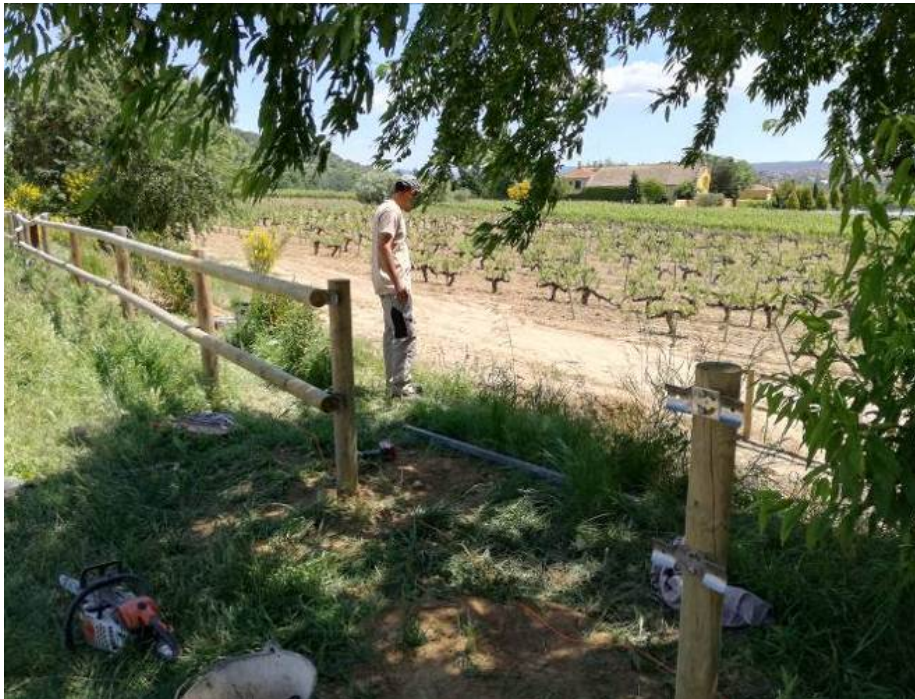
Installation work of the wooden fence on the top of the pond.

An additional 6m fence has also been installed following an existing fence at the top of the stone wall.

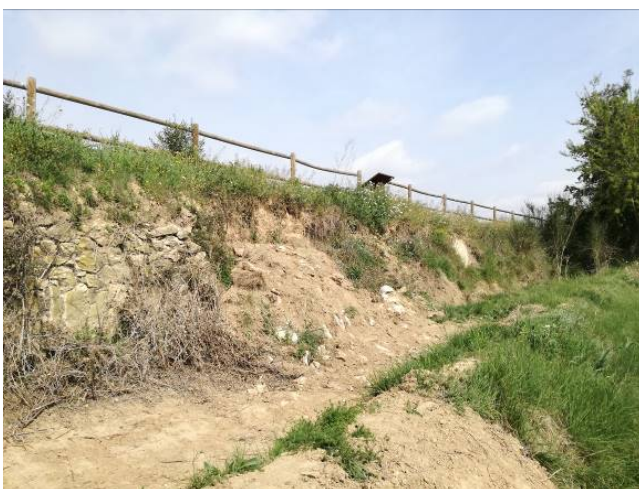
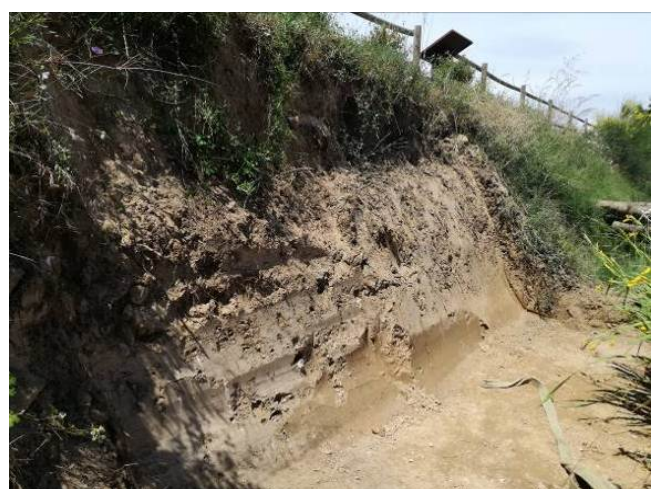
Image of the area of the slope where the live slope grid has been built before starting the work, and the re-profiled slope with machinery ready to install the live slope grid.

A 4.5m long and 3m high live slope grid has been installed to stabilise a section of vertical slope affected by the deterioration of part of a wall.

The earth accumulated at the base has been removed, re-profiling work has been carried out and subsequently the structure of the live slope grid has been generated with wooden logs, 2 verticals anchored to the ground and the horizontals anchored to the first ones.

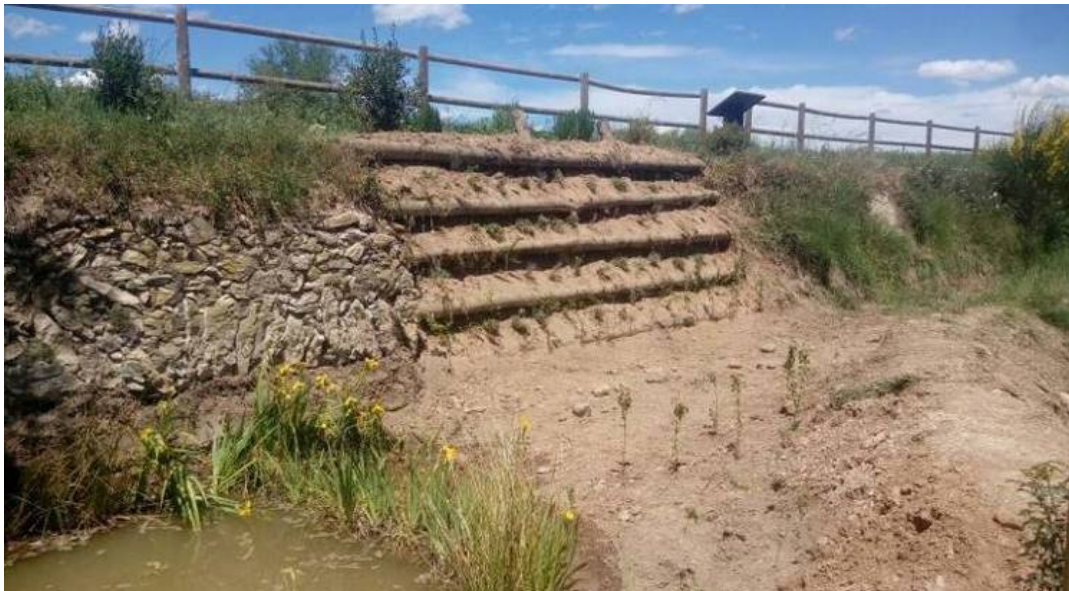
Image of the slope after the work with the living slope grid and the plantations.

Below is a detail of the plantation done on the slope grid to favour the presence of butterflies, with species of interest to them and others to give stability to the slope with the structure of its root system.

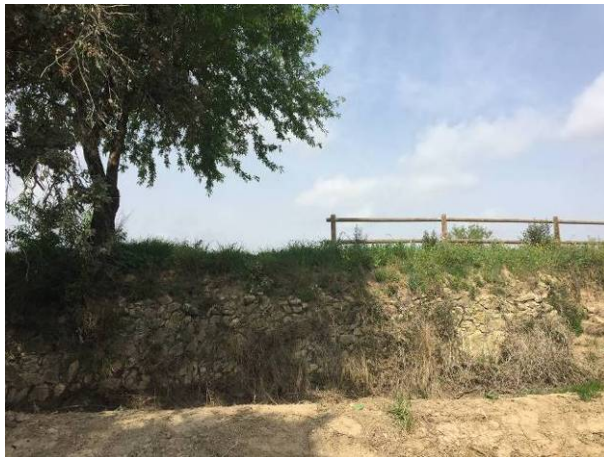
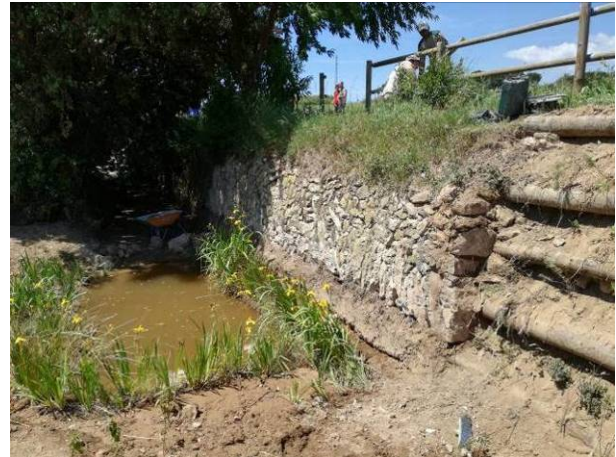
Initial state of the stone wall / Stone wall cleaned and with redone transfer between the stone wall and the live slope grid installed.
