# **Executed project report**

## Works of naturalization of the Palmeral zone pond Barcelona Zoo

Author of the proposal and execution: Naturalea

Client: B:SM Zoo de Barcelona Start and finish: July 2019

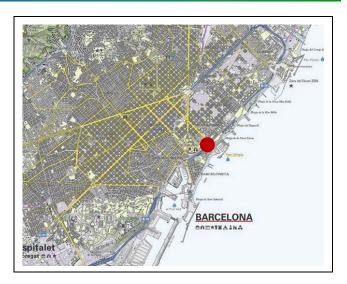
The objective of the intervention carried out in the Palmeral area of the Barcelona Zoo was to convert a concrete pond into a naturalized pond. The area of the action zone was approximately 70m<sup>2</sup>.

To promote biodiversity, different work has been done to diversify the margins: revegetation with helophytes, provision of gravel and stone of different sizes and wooden structures, creating different environments and areas of ecological niche.

With this intervention, we converted a concrete pond for animals into an NBS system with effects on biodiversity, improving air and water quality - we created a hyporheic zone - in the retention of humidity and acting as a rain garden for stormwater.

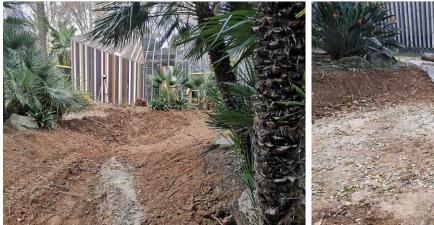
Earth movements to define the new orography of the pond

- Earth movements to define the new orography of the pond.
- Displacement and adaptation of the irrigation system.
- Adaptation of the overflow system of the old pond
- Adaptation of the water entry zone.
- Creation of a low point to facilitate emptying with a pump system for special maintenance.

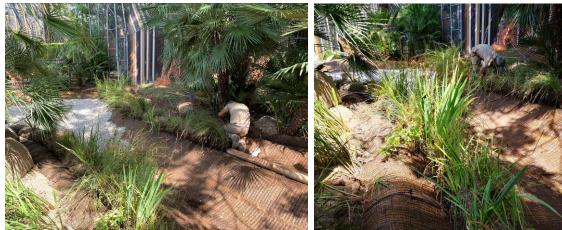
Installation of the permanent geogrid and placement of gravels

- Installation of geotextile and EPDM sheet.
- Installation of the permanent geogrid type C350 Vmax.
- Placement of gravel on the entire pond.

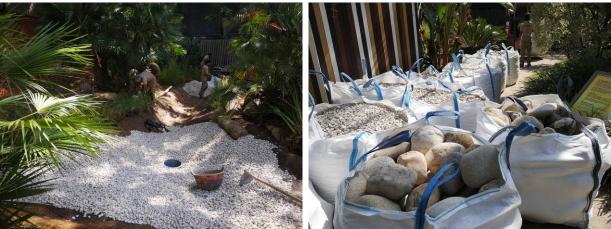
Placement of gravel and disposal point / Detailed picture of the placed material

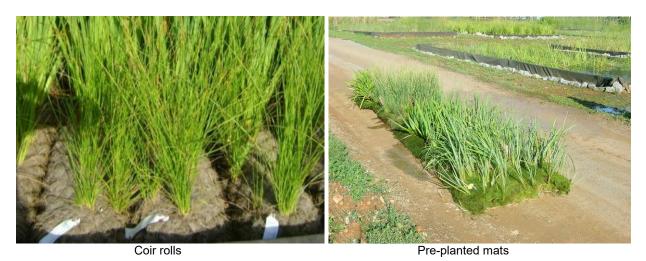
- Installation of helophytic vegetation on the margins with Coir Rolls and Pre-planted mats.

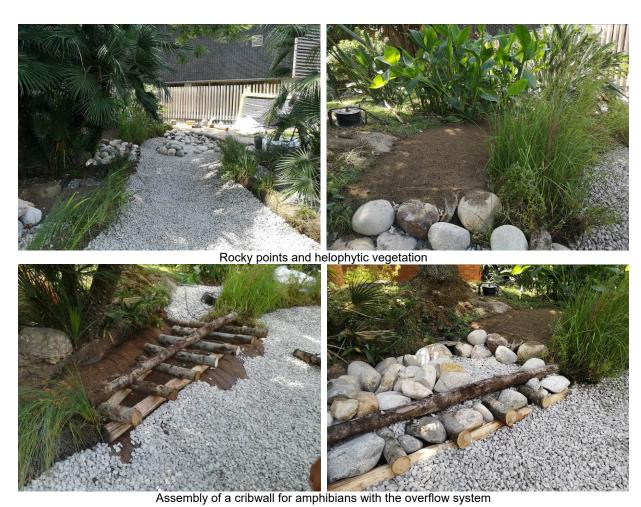
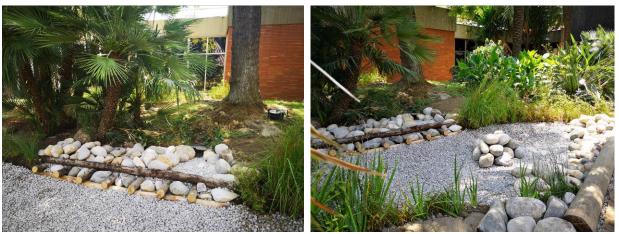
General view of the actions of margins diversification

- Creation of rocky points on the margins.
- Construction of a cribwall as a refuge for amphibians.
- Provision of soil on the margins behind the vegetation to link up with the existing parterres.

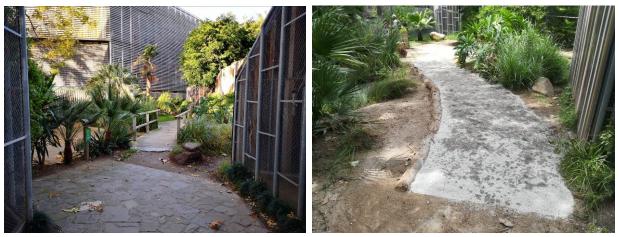
Before and after of the creation of the new path with granite crushing

- Adaptation and repair of the existing path that borders the pond due to the impact of the works and other improvement details.
- Creation of a new path by adding granite crushing in size 3/7 mm and delimiting it with unpeeled chestnut wood logs.

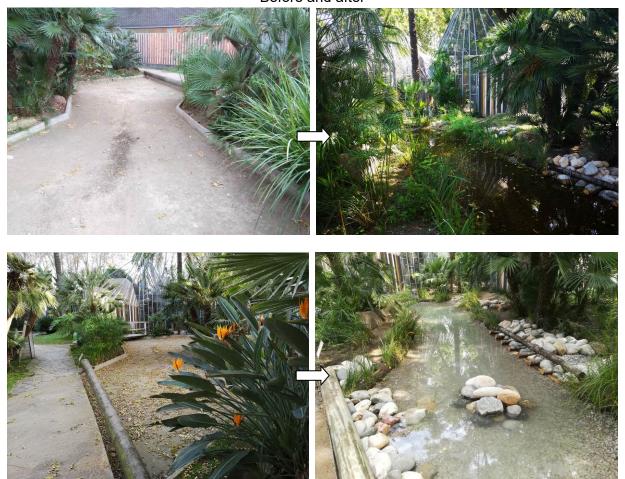
Before the action and the day the pond began to fill.

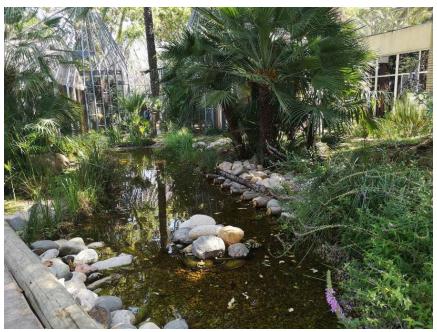
Image of the pond two months after the intervention.
